[Docket No. FAA-2012-0773; Directorate Identifier 2009-SW-71-AD]

Airworthiness Directives; Eurocopter Deutschland GmbH Helicopters

ACTION: Notice of proposed rulemaking (NPRM).

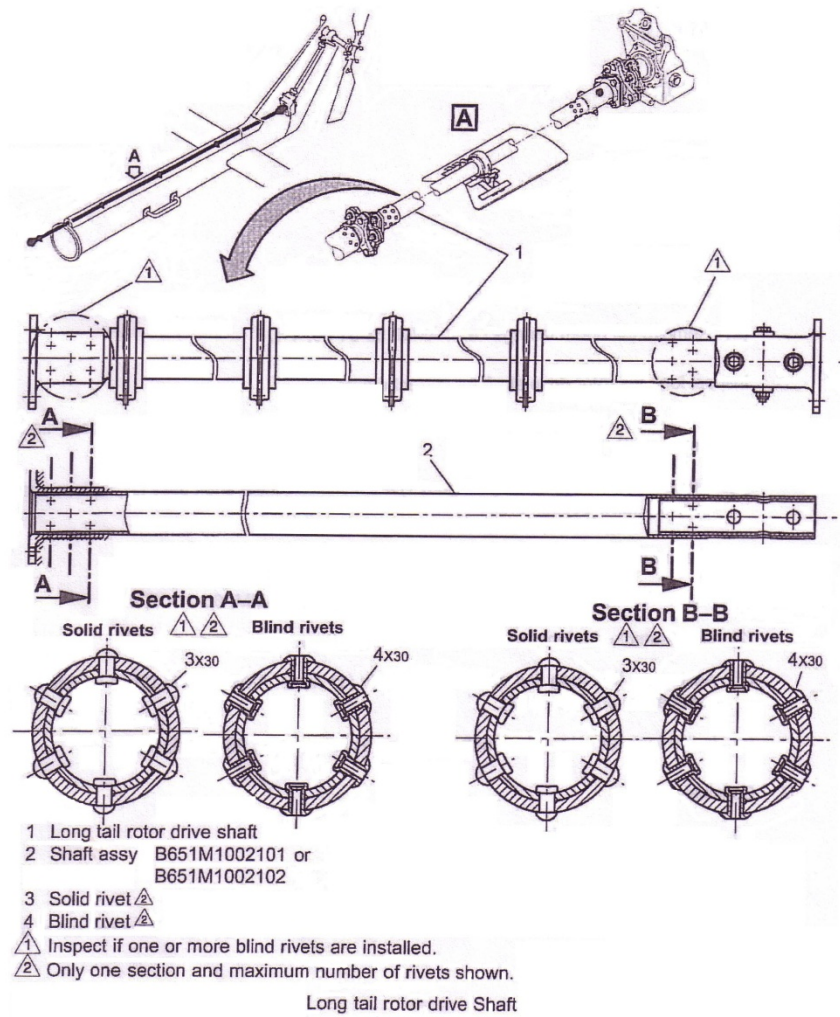
This AD defines the unsafe condition as the installation of blind rivets instead of solid rivets in the long tail rotor drive shaft. This condition could result in failure of the long tail rotor drive shaft and subsequent loss of control of the helicopter.

Within 100 hours time-in-service (TIS), inspect the long tail rotor drive shaft assembly for blind rivets as indicated in sections A-A and B-B of Figure 1 to Paragraph (d) of this AD.

(2) If there are one or more blind rivets installed on the shaft assembly in the areas depicted in Figure 1 to Paragraph (d) of this AD, before further flight, replace the shaft assembly of the long tail rotor drive shaft with an airworthy shaft assembly that does not have blind rivets installed.
